**LAKE ASHBURTON**

**NDI ID NO. MD-108**

**PHASE I INSPECTION REPORT  
NATIONAL DAM INSPECTION PROGRAM**

**JUNE 1980**

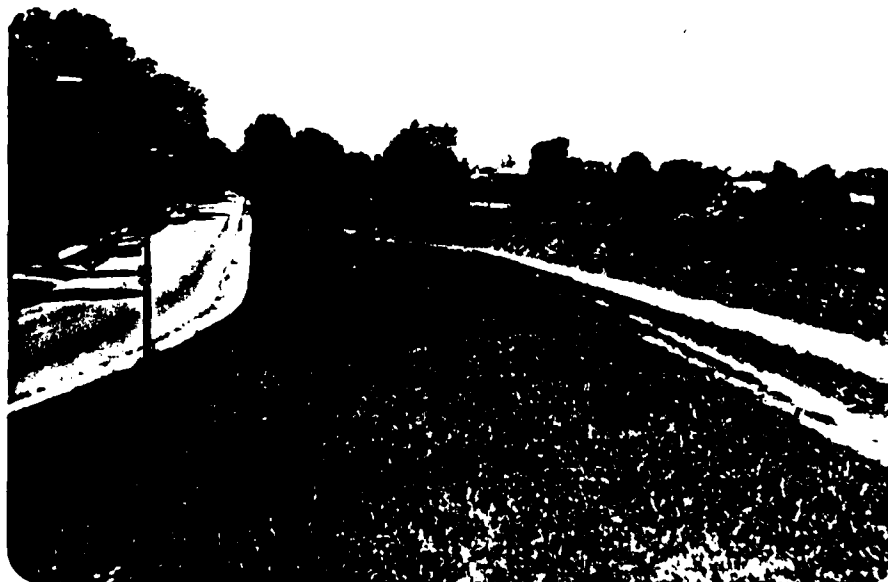
D. Downstream Slope of  
Southern Embankment
